# Advisory services to support the recovery of school infrastructure in Mexico affected by the September 2017 earthquakes

## EXECUTIVE SUMMARY

December 2018

# The recovery of school infrastructure in Mexico affected by the September 2017 earthquakes

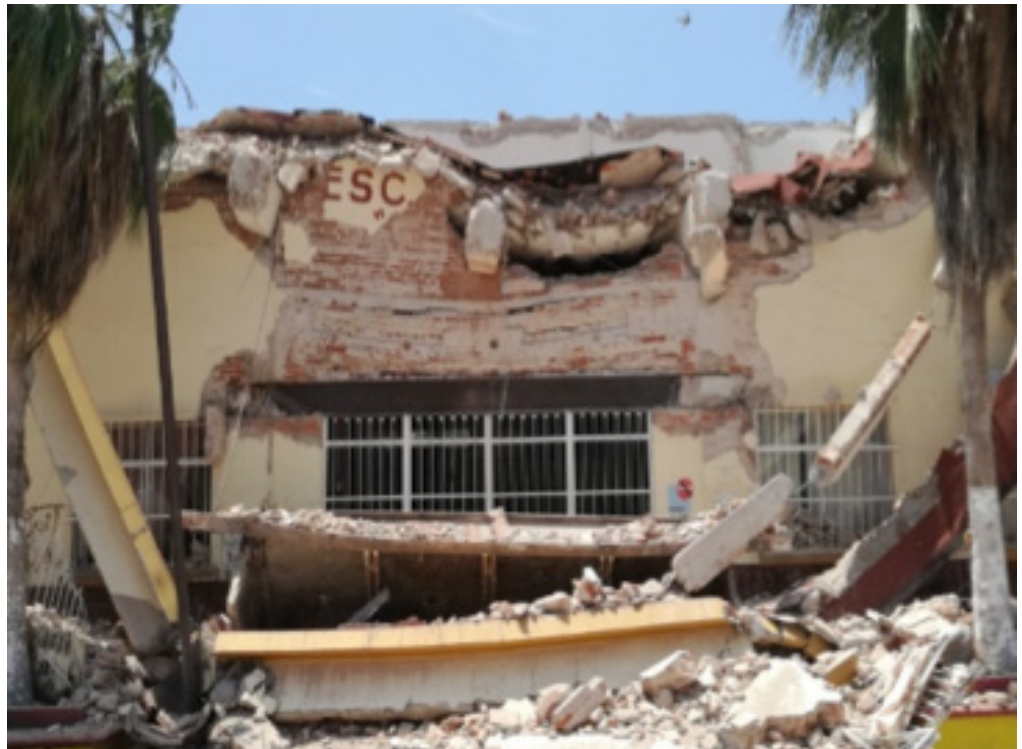
As indicated above, four buildings collapsed. Two were “atypical” masonry structures; one was a steel structure and the fourth was similar to a prototype masonry structure. Collapses seem to be associated to low quality construction and lack of seismic design.

Figure 2. Partial collapse of the school building.

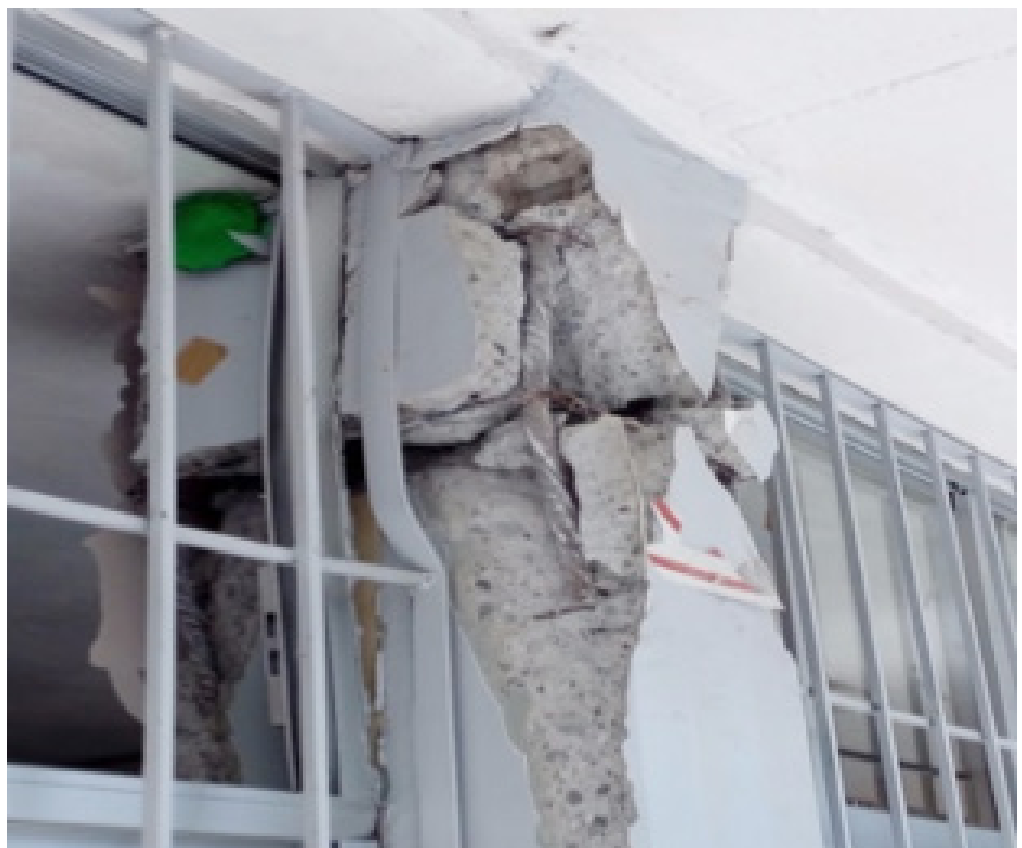
For concrete structures, most damage was concentrated in columns, especially due to the “short column” effect. Although CAPFCE’s and INIFED’s drawings clearly specified a typical 20-to-25-mm separation between columns and sill walls, existing walls were directly constructed against columns. Under earthquake-induced lateral displacements, stiffer columns had to resist larger shear forces for which they were under designed and not detailed for.

Moreover, column transverse reinforcement was widely spaced (at 300 mm typically) and was made of stirrups with 90-deg bends at the ends. The need for improved construction inspection is evident. Beam shear cracking and concrete spalling were seldom observed. In few cases, beam-column joint cracking and spalling were recorded.

Figure 3. Short column type of damage in school building.

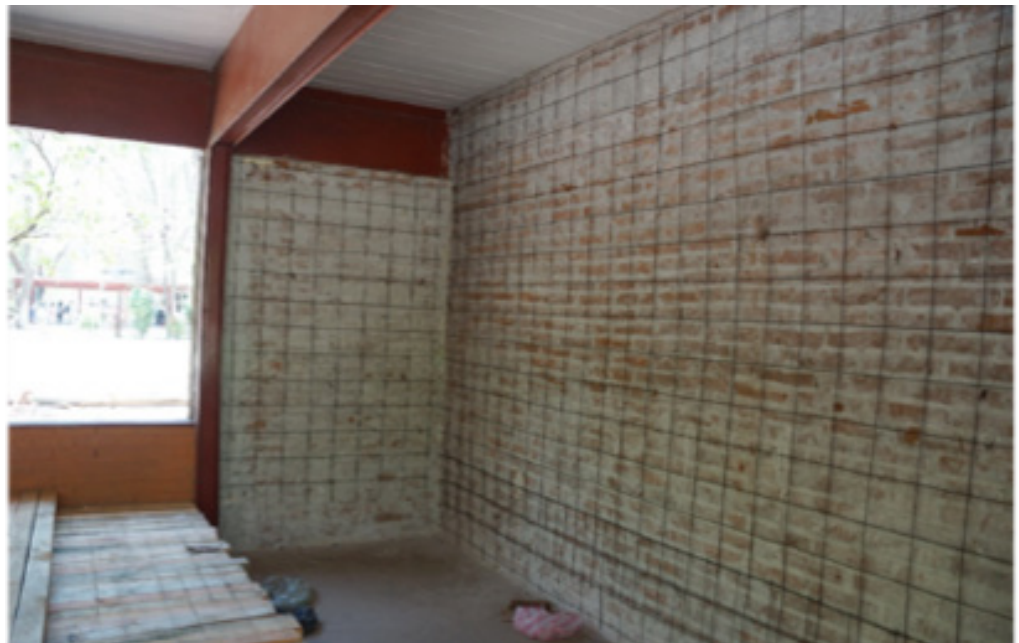
Figure 4. Retrofitting of the structure with a reinforced concrete layer.

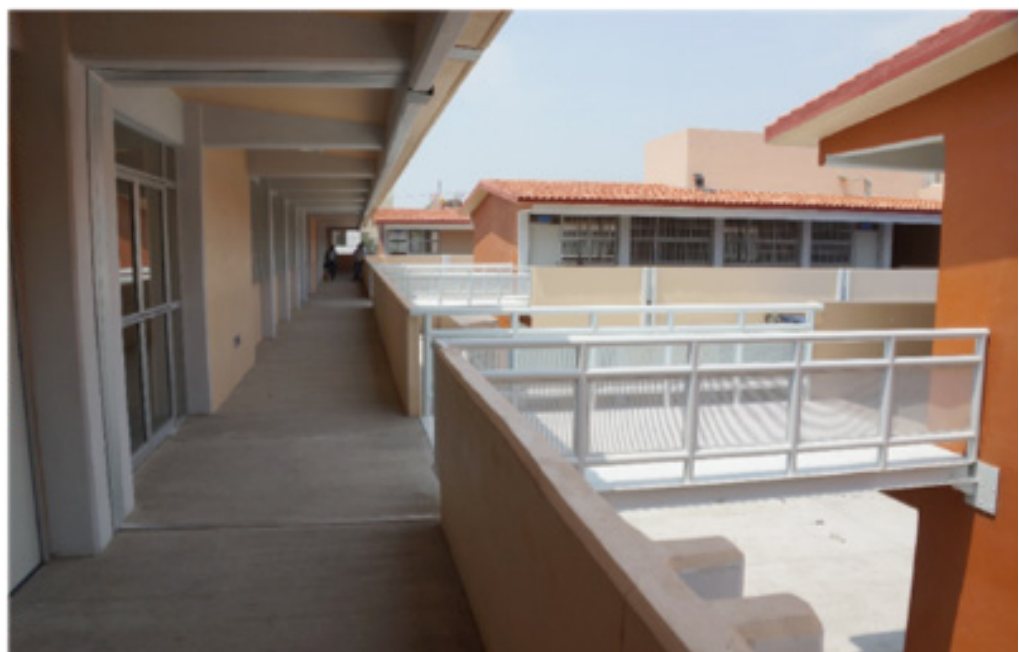
Figure 5. Retrofitted school.

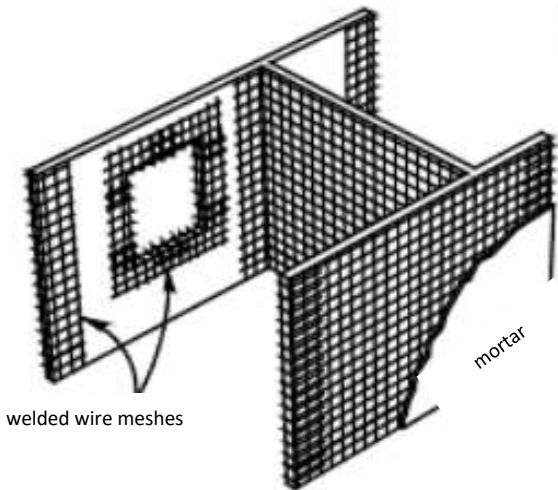
| Seismic retrofitting technique | General description | Technique scheme/figure | Type of school building used for performance analysis | Improvements in seismic performance |
|---|---|---|---|---|
| | | | Masonry school building -<br>1 story - 4 classrooms<br>Taxonomy - CM/ LR/ MD/ RR/ NO/ LP/ LO/ SF/ NP/ RS/ GC/ VC | Increase resistance to seismic forces. The performance level "immediate occupancy (IO)" is reached for most seismic zones and soil types in Mexico*. For zone D with soil II and zone C with soils II y III, the technique requires improvements to reach IO. |

| Seismic retrofitting technique | General description | Technique scheme/figure | Type of school building used for performance analysis | Improvements in seismic performance |
|---|---|---|---|---|
| Jacketing of masonry walls with welded wire mesh (WWM) covered with cement mortar | This technique has been used in load bearing walls in rural schools, as well as in infill walls of concrete and steel moment frames. Typically, meshes with 10- and 6-gauge wires, spaced at 150 mm, are used | | Masonry school building -<br>1 story - 1 classroom<br>Taxonomy: CM/ LR/ MD/ RR/ NO/ LP/ LO/ SF/ NP/ RS/ GC/ VC | Increase resistance to seismic forces. The performance level "immediate occupancy (IO)" is reached for most seismic zones and soil types in Mexico*. For zone D with soils II and III, the technique requires improvements to reach IO. |

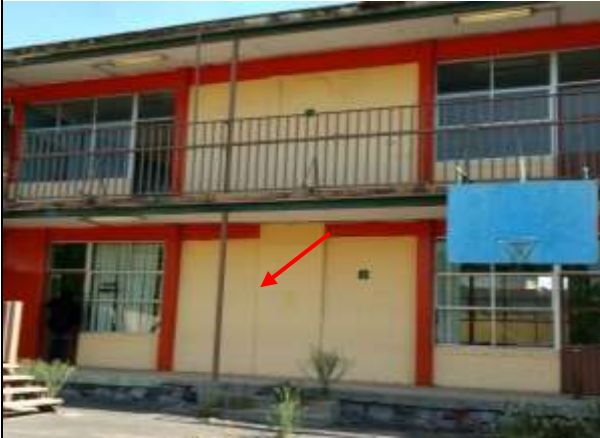
| Seismic retrofitting technique | General description | Technique scheme/figure | Type of school building used for performance analysis | Improvements in seismic performance |
|---|---|---|---|---|
| | | | Concrete school building - 4 stories<br>Taxonomy: RC2/ MR/ LD/ RF+RR/ NO/ LP/ SW/ SF/ NP/ RS/ GC/ VC | Increases both stiffness and resistance to seismic forces. The performance level "immediate occupancy (IO)" is reached only for seismic zone C and soil type I in Mexico*. For other zones and soils, the technique requires improvements to reach IO. |

| Seismic retrofitting technique | General description | Technique scheme/figure | Type of school building used for performance analysis | Improvements in seismic performance |
|---|---|---|---|---|
| Addition of new concrete walls to resist earthquake-induced lateral forces | This technique includes construction of flange walls attached to concrete columns. New concrete walls have been added to concrete and steel moment frames with one to four stories high. Typical wall thicknesses are 150 mm for buildings with one and two stories, and between 200 and 250 for taller structures | | Concrete school building - 1 story<br>Taxonomy: RC2/ LR/ LD/ RR/ NO/ LP/ SW/ SF/ NP/ RS/ GC/ VC | Increases both stiffness and resistance to seismic forces. The performance level "immediate occupancy (IO)" is reached for all seismic zones and soil types in Mexico*. |
