**Crucecitas, Mexico Mw 7.4  
 Earthquake**

June 23, 2020

**PRELIMINARY VIRTUAL RECONNAISSANCE REPORT (PVRR)**

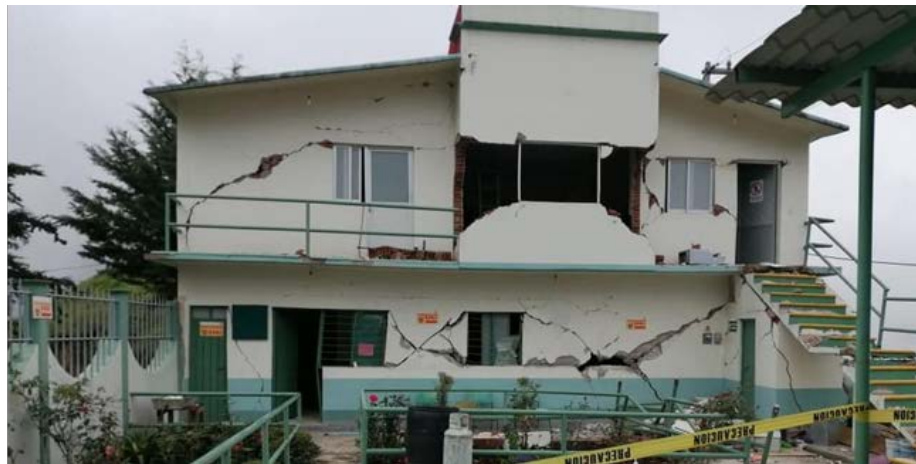
**Structural failure of a medical unit located in Oaxaca, Mexico (Twitter, 2020).**

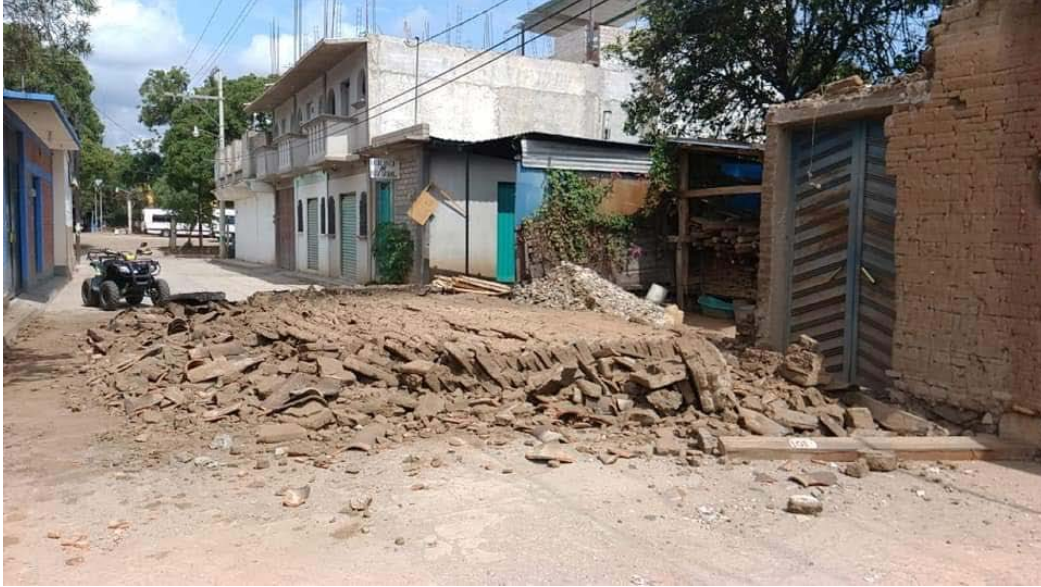
**Figure 7.2. Top: Out-of-plane collapse of a boundary wall in an adobe residential construction, Oaxaca (Twitter, 2020e); Bottom: collapse of a confined masonry wall in a residential building, Santa Cruz Ozolotepec (Facebook, 2020a).**

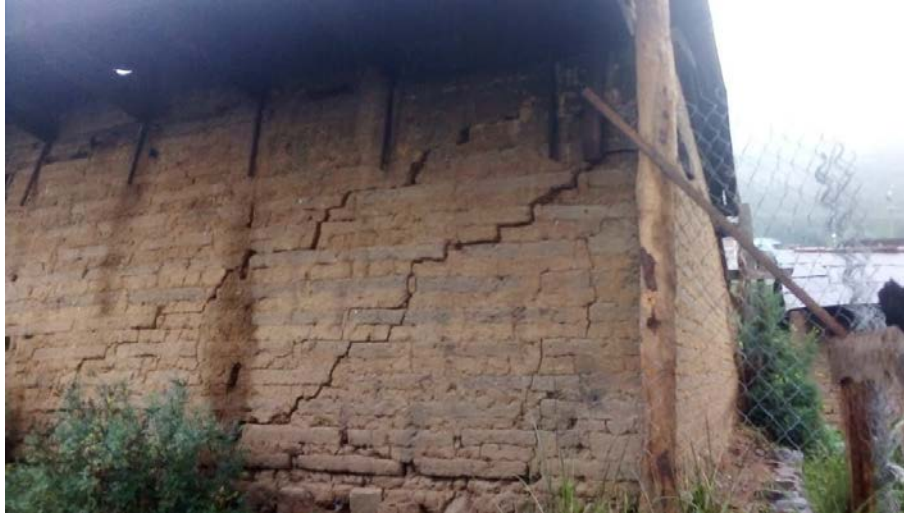
Figure 7.4. Severe diagonal tension cracking in a wall of an adobe house, Oaxaca (Its going down, 2020).

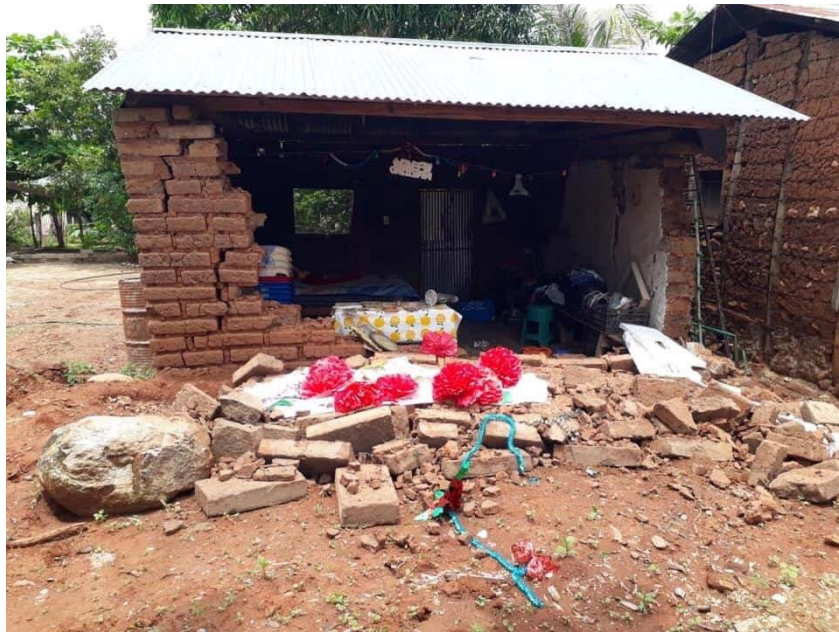
Figure 7.5. Out-of-plane collapse of a wall in an adobe house (Twitter, 2020g).

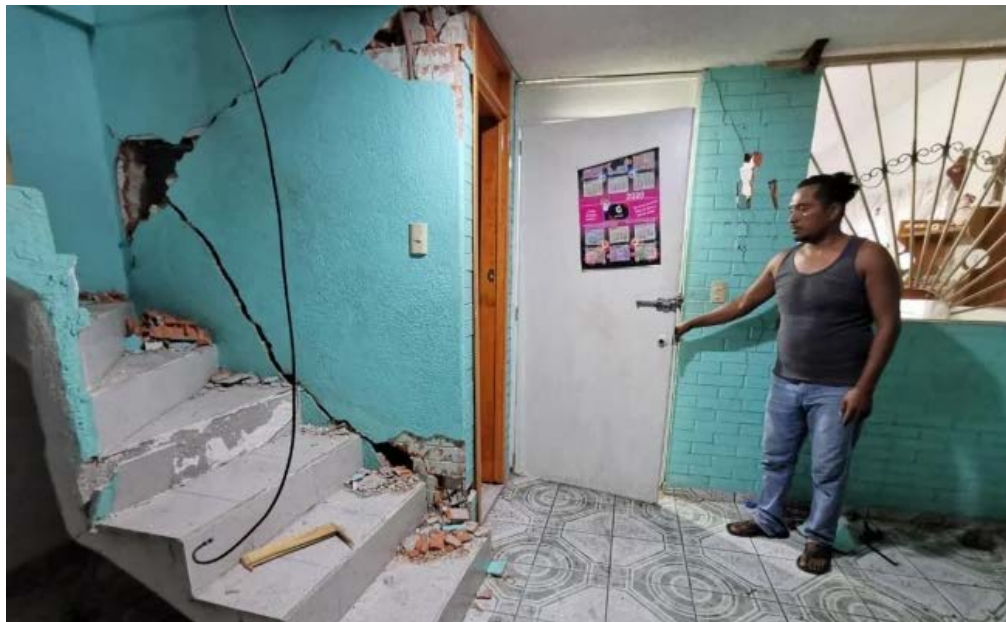
Figure 7.8. Damage to masonry bearing wall in the first story of a two-story residential structure in Oaxaca (El Universal, 2020c).

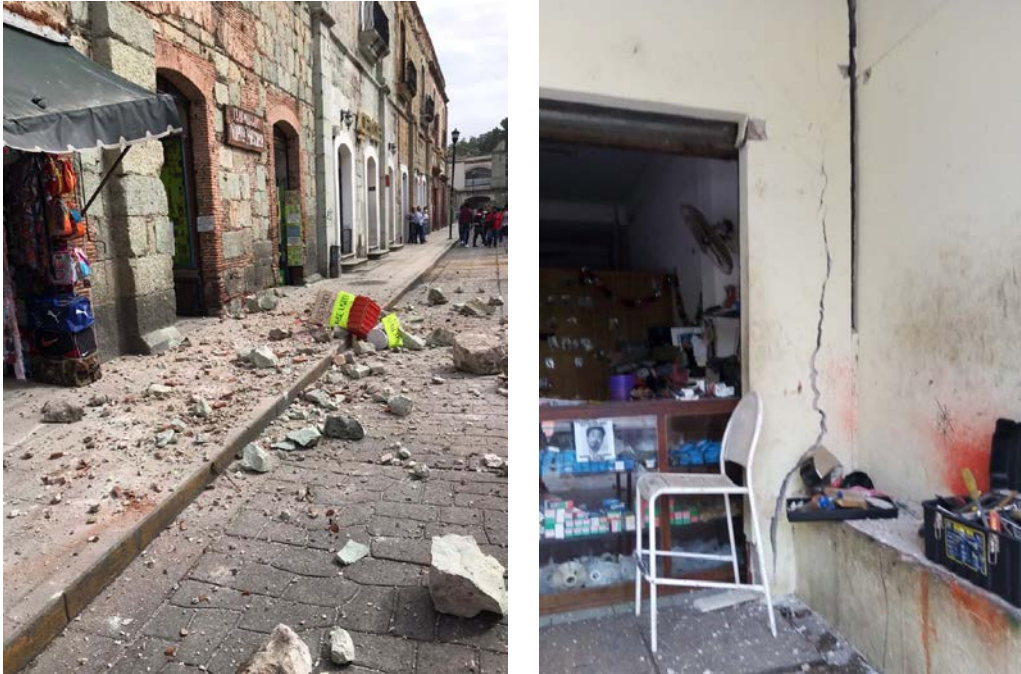
**Figure 7.14. Failure of adobe walls in central Oaxaca (left), (Twitter, 2020k) and masonry wing wall damage and detachment (right) (Estado 21, 2020).**

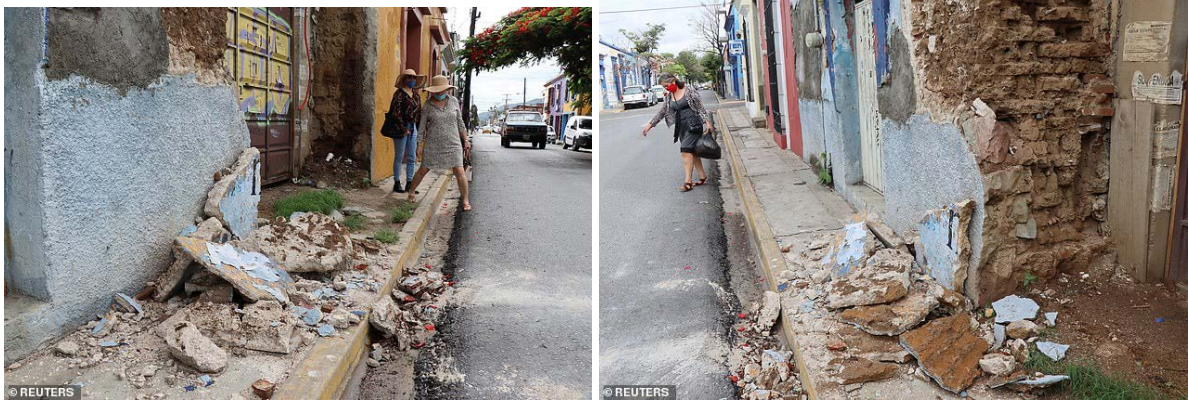
**Figure 7.15. Failure of masonry walls and spalling of plaster in Oaxaca (Distinct Today, 2020).**

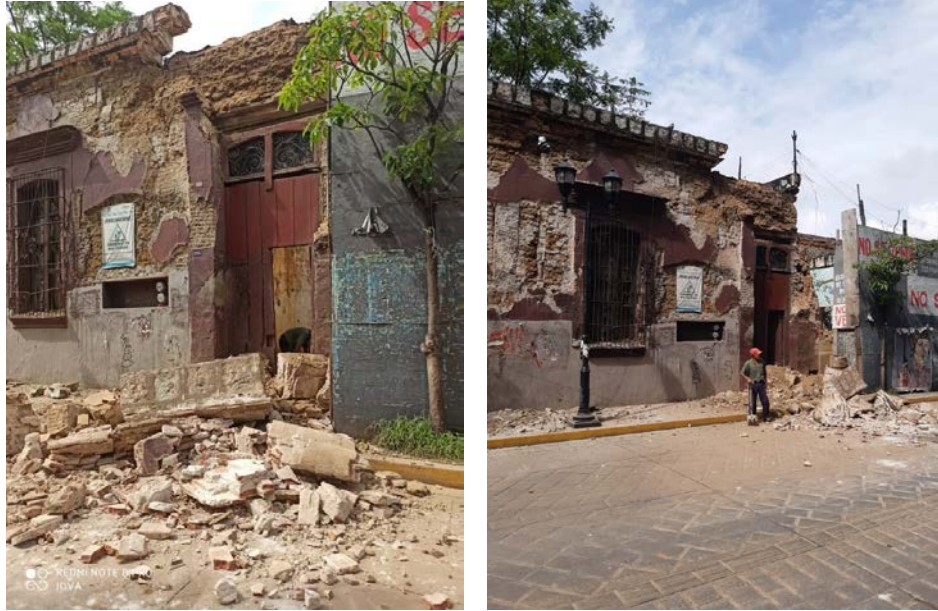
**Figure 7.16. Damage to the facade of the historical building located at the center of Oaxaca (Twitter, 2020q; Twitter, 2020i).**

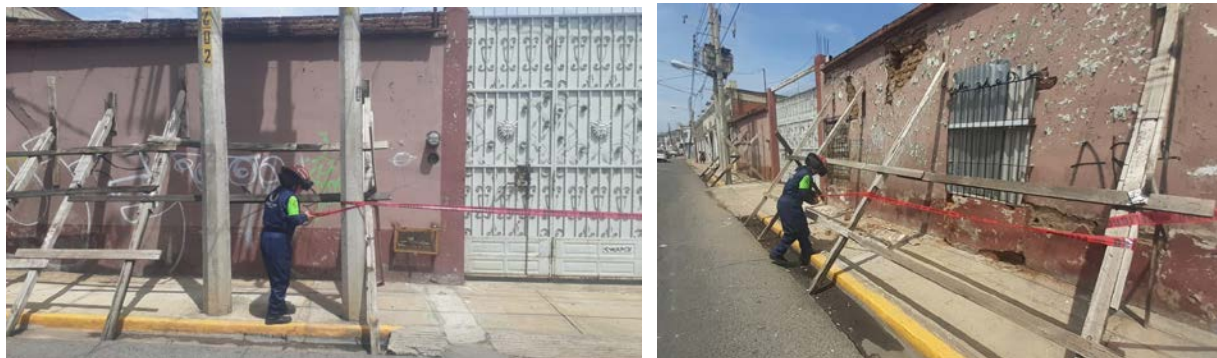
**Figure 7.17. Damage and temporary propping of a masonry wall (Twitter, 2020r).**

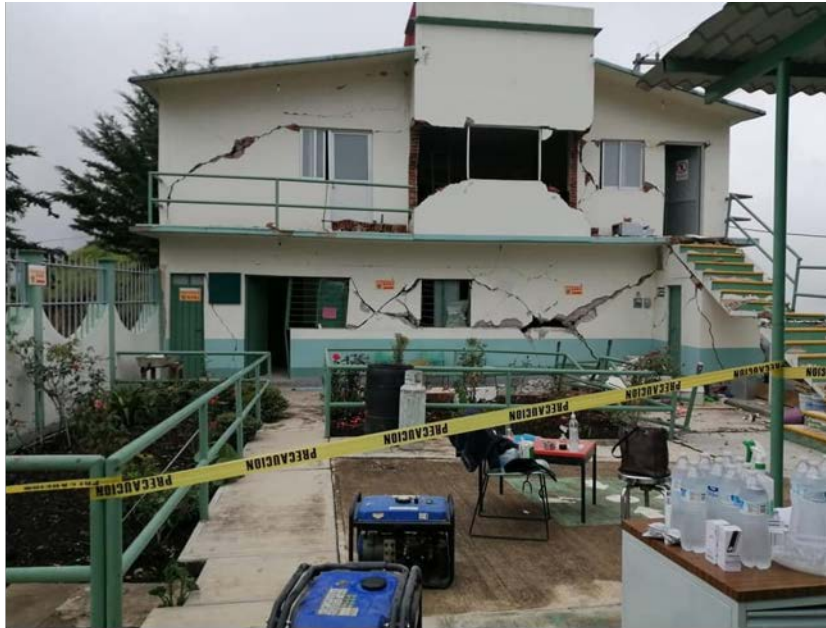
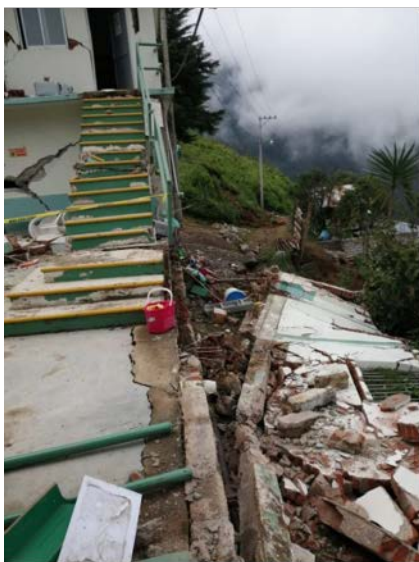
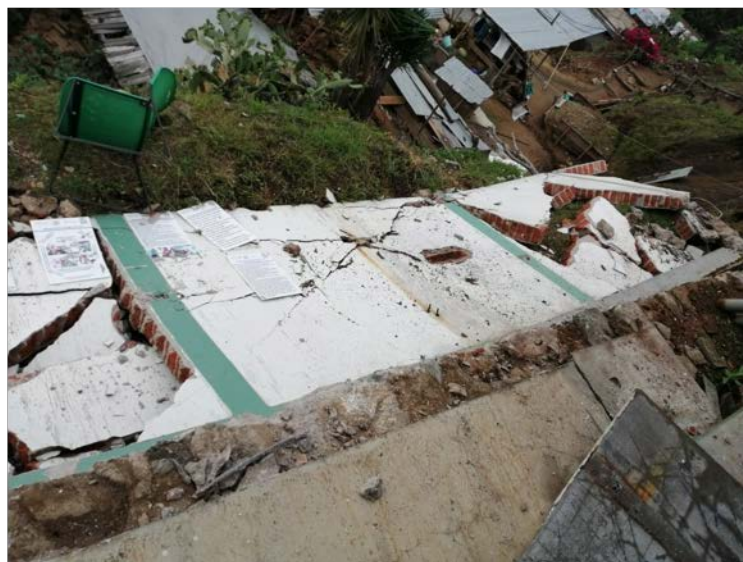
**Figure 7.18. Failure of unreinforced masonry wall of the medical unit located at Santa Catarina Xanaguía in the San Juan Ozolotepec municipality, Oaxaca (Twitter, 2020I).**

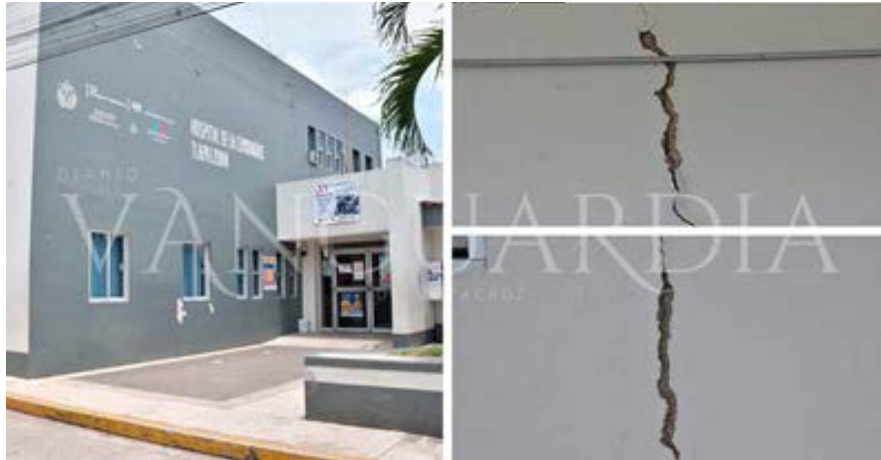
**Figure 7.21. Damage to the Civil hospital at Tlapacoyan, Veracruz (Vanguardia, 2020).**

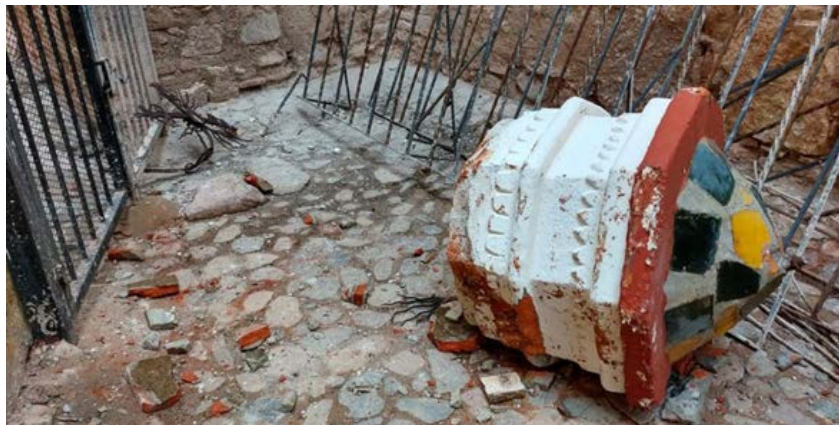
**Figure 7.24. Collapse of ornamentation in the San Mateo Macuilxóchitl church in the Tlacoahuaya, Oaxaca (Guerrero en Vivo, 2020).**

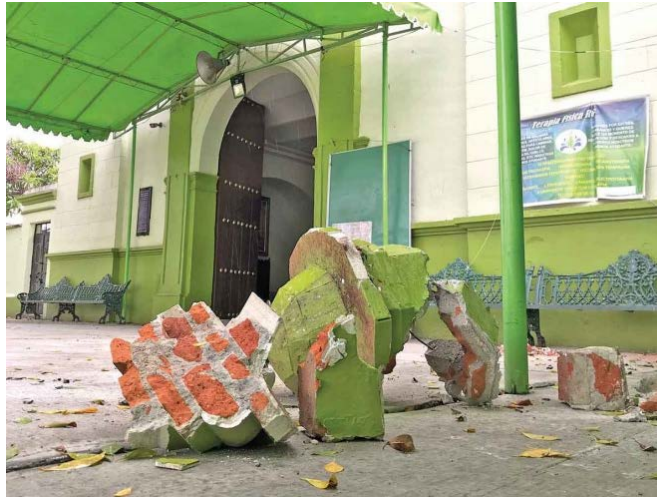
**Figure 7.25. Collapse of parapet ornamentation in the church of Santísima Trinidad de las Huertas, City of Oaxaca. (Excelsior, 2020b).**

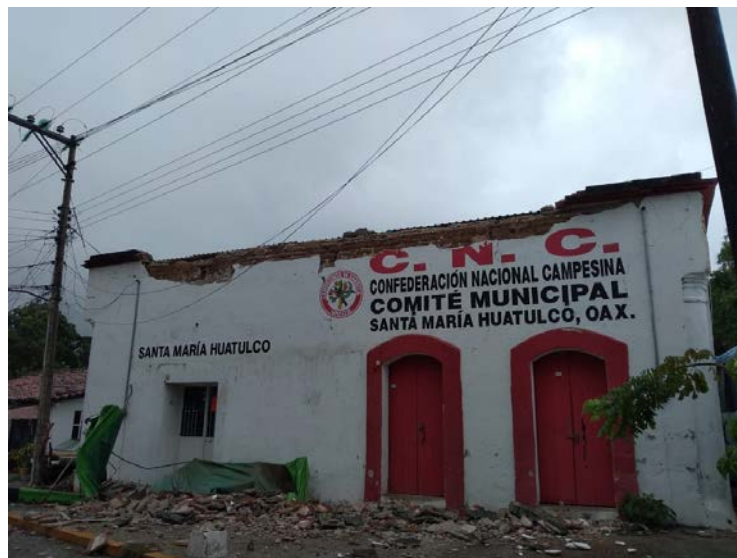
**Figure 7.26. Collapsed unreinforced masonry parapet in a government building in Huatulco, Oaxaca (Puerto Vallarta Daily News, 2020).**

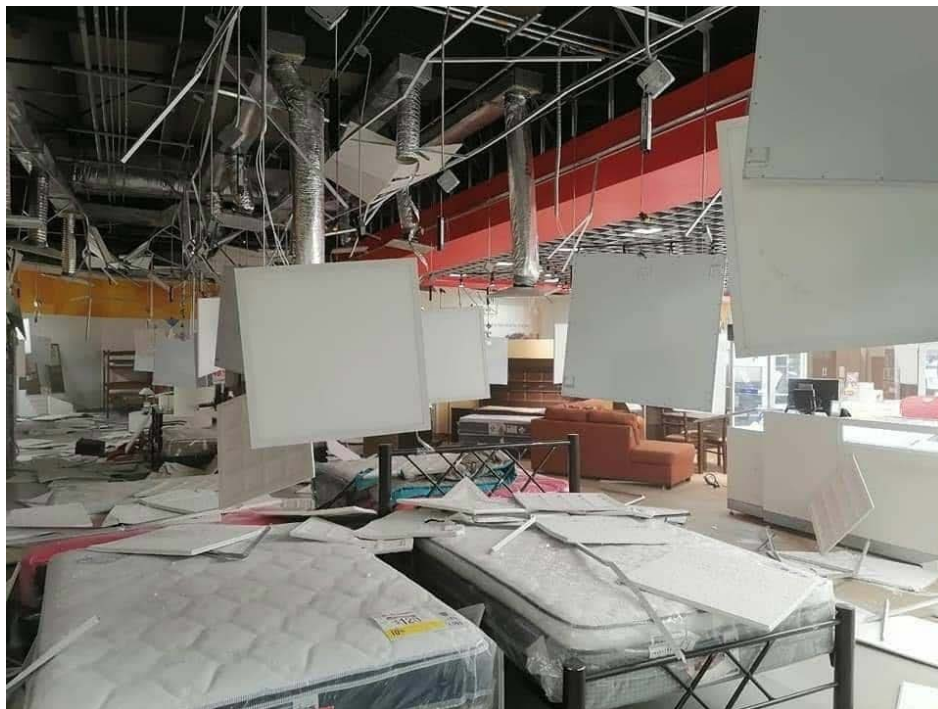
**Figure 7.27. Collapsed acoustical ceiling in a furniture store in the city of Oaxaca (Facebook, 2020c).**

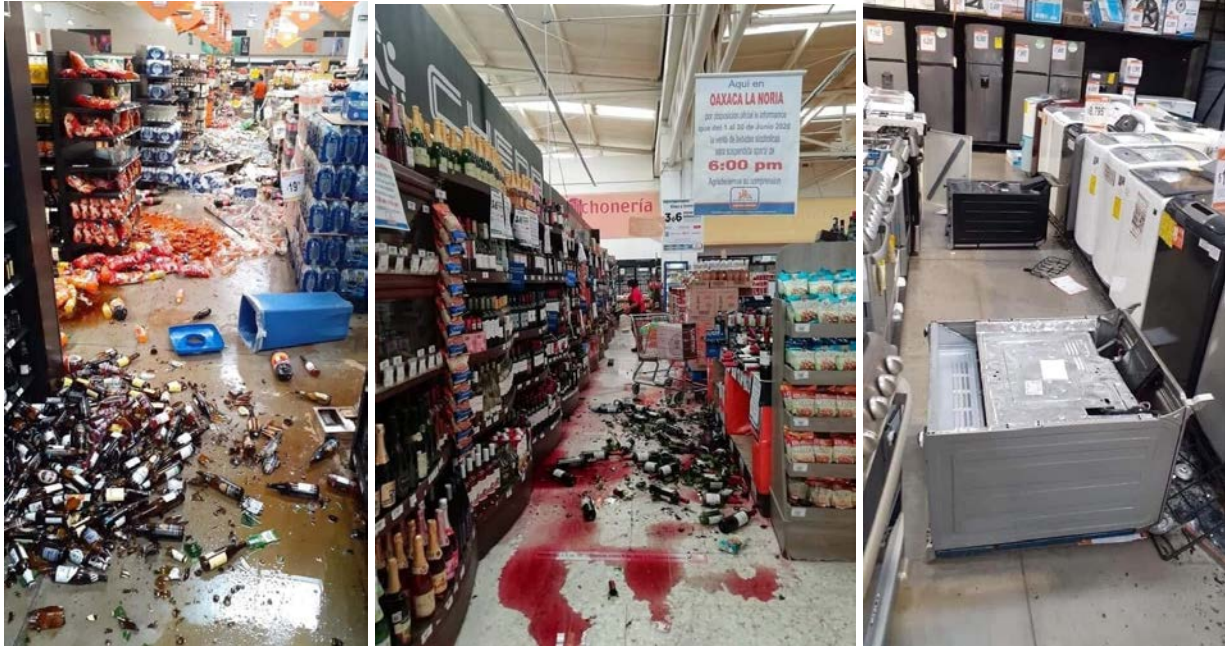
Figure 7.28. Non-structural damage in a large grocery store in the city of Huatulco in the state of Oaxaca. (Facebook 2020d, Facebook 2020e, and Facebook 2020f, for left, center and right, respectively).

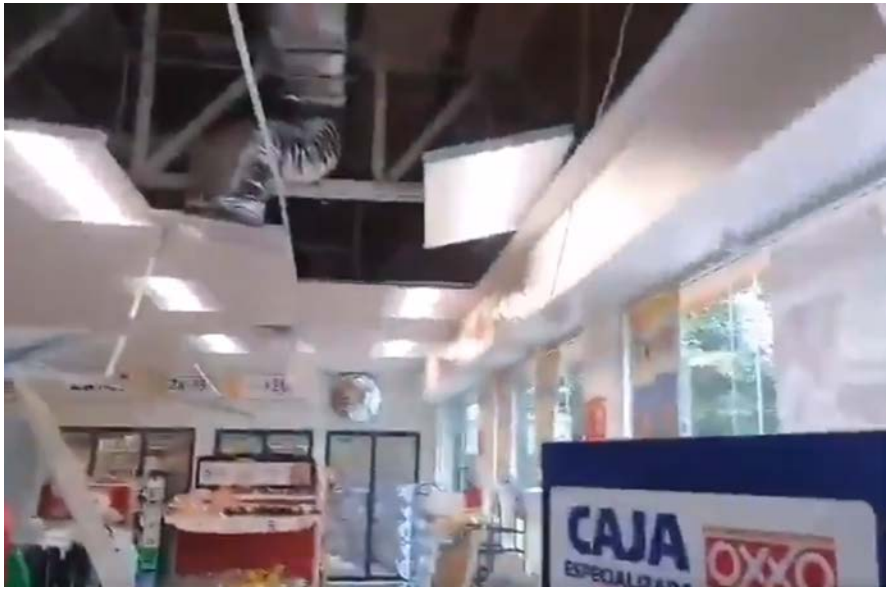
Figure 7.29. Non-structural damage in a store in Oaxaca (Twitter, 2020m).

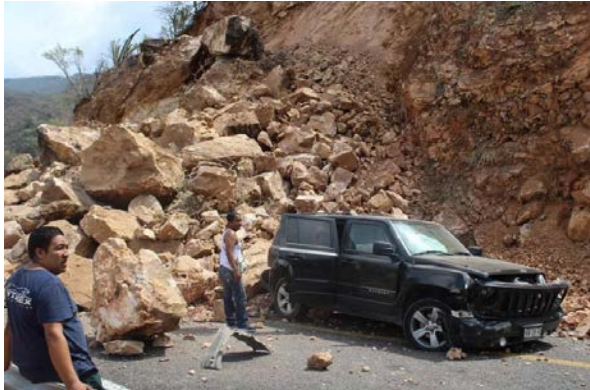
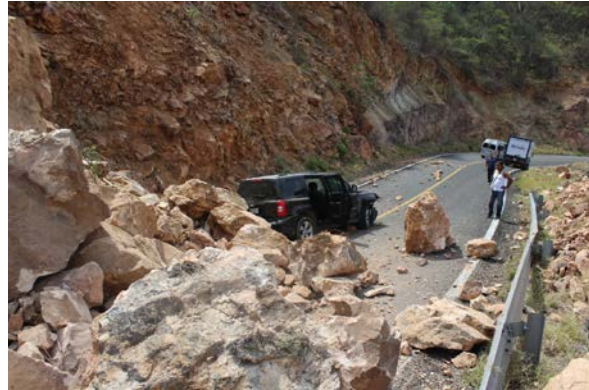
Figure 7.31. Landslide in Paso Ancho, Santa María de Huatulco, Oaxaca (Facebook, 2020g).

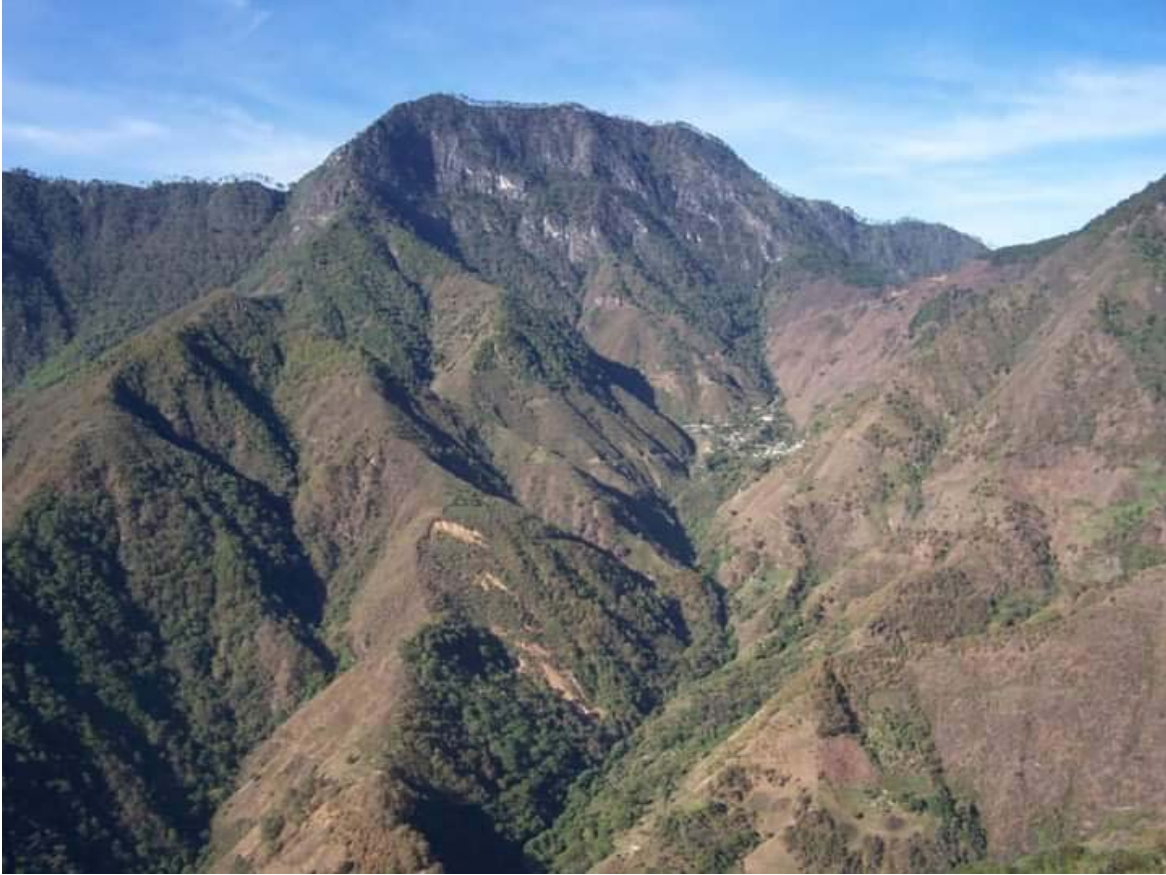
**Figure 7.33. Landslide of Cerro La Sirena, which affected the town of Santa Catarina Xanaguia, located at the back (Twitter, 2020n).**

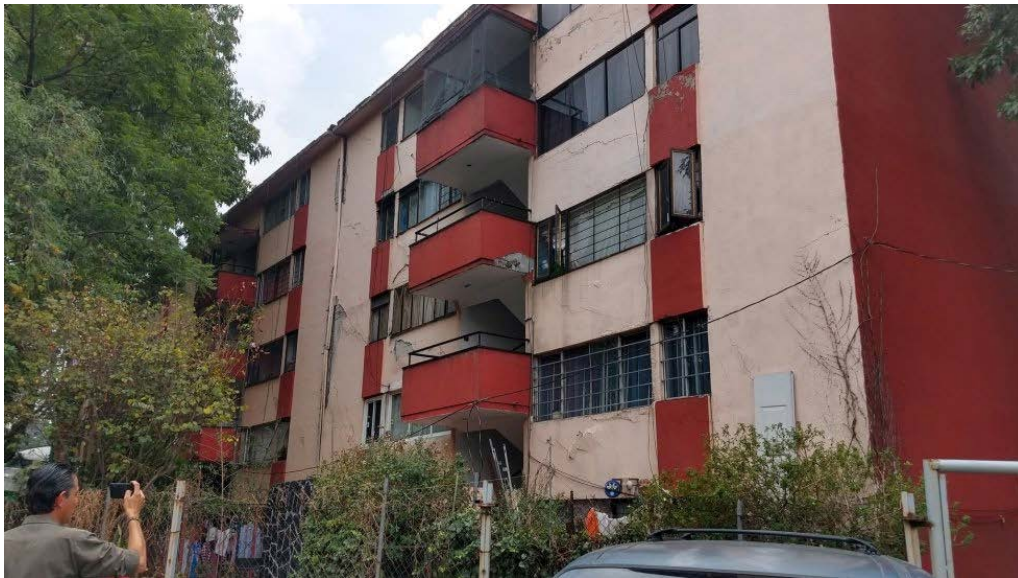
**Figure 8.1. Apartment building tilted at Unidad Habitacional Lindavista-Vallejo in Mexico City (Lopez-Doriga, 2020).**

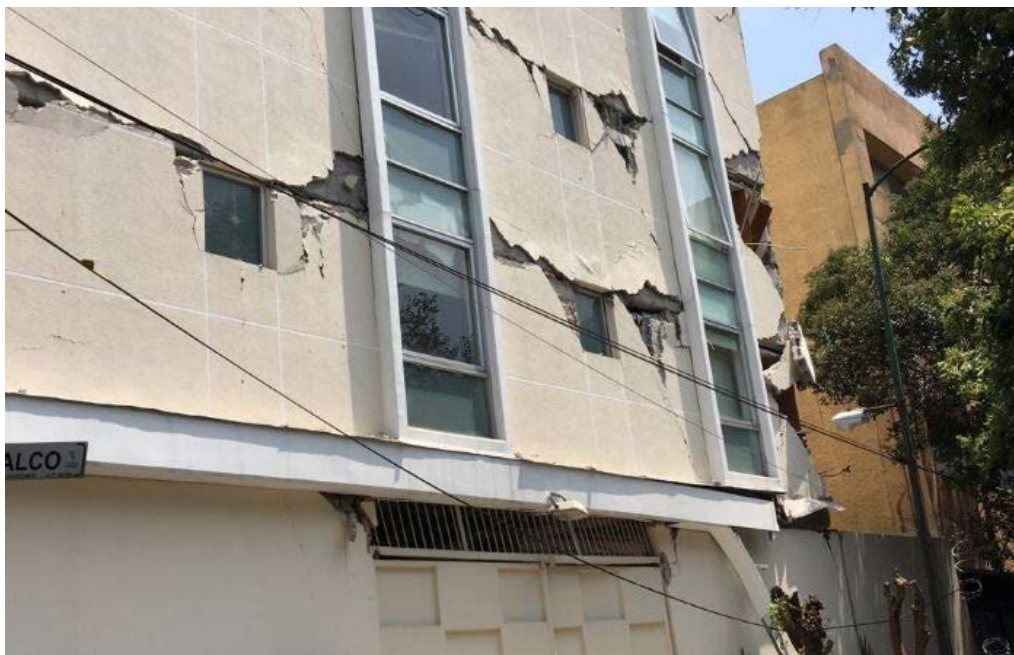
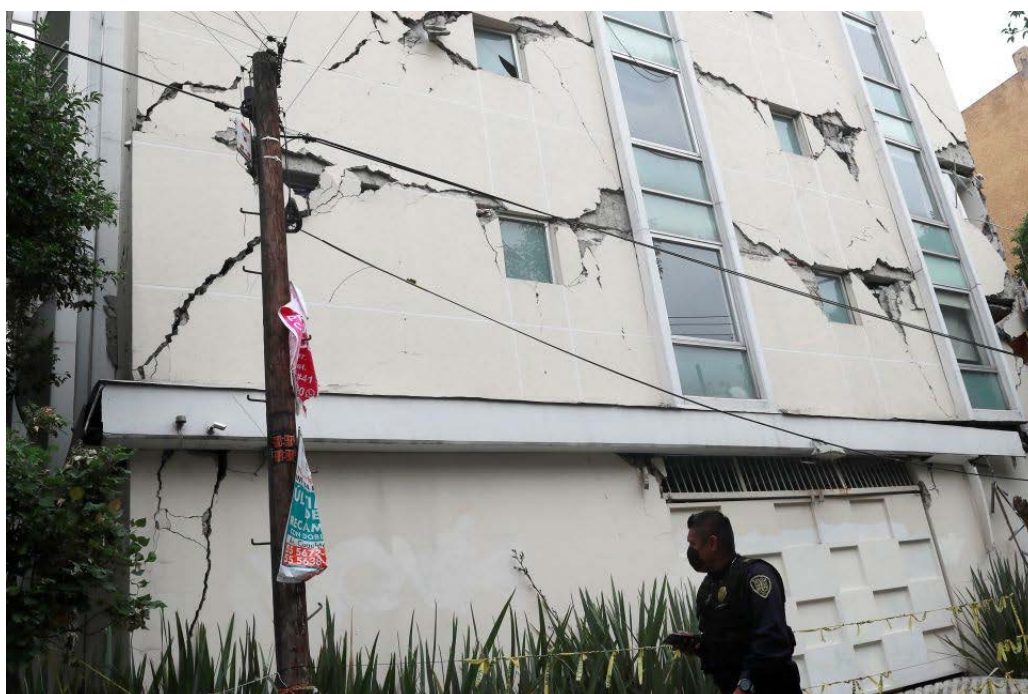
**Figure 8.3. Damage in the building located at Tepic 40 in Mexico City after the 2017 earthquake [top] (Cara, 2017) and after the 2020 earthquake [bottom] (Redacción ADN40, 2020).**

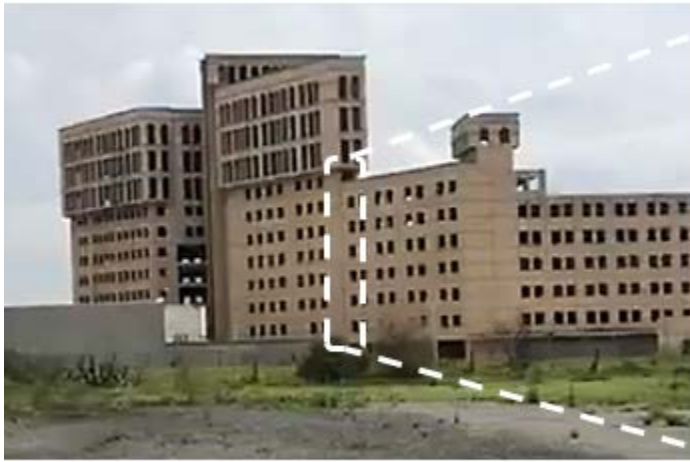
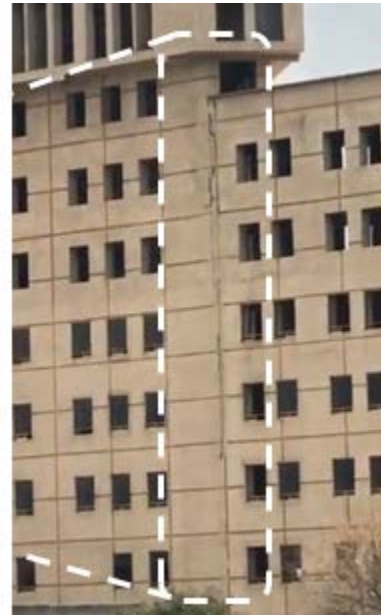
**Figure 8.4. Damage produced by pounding at Hotel Miled located in the Metepec municipality, Mexico State (QuieroTV, 2020).**

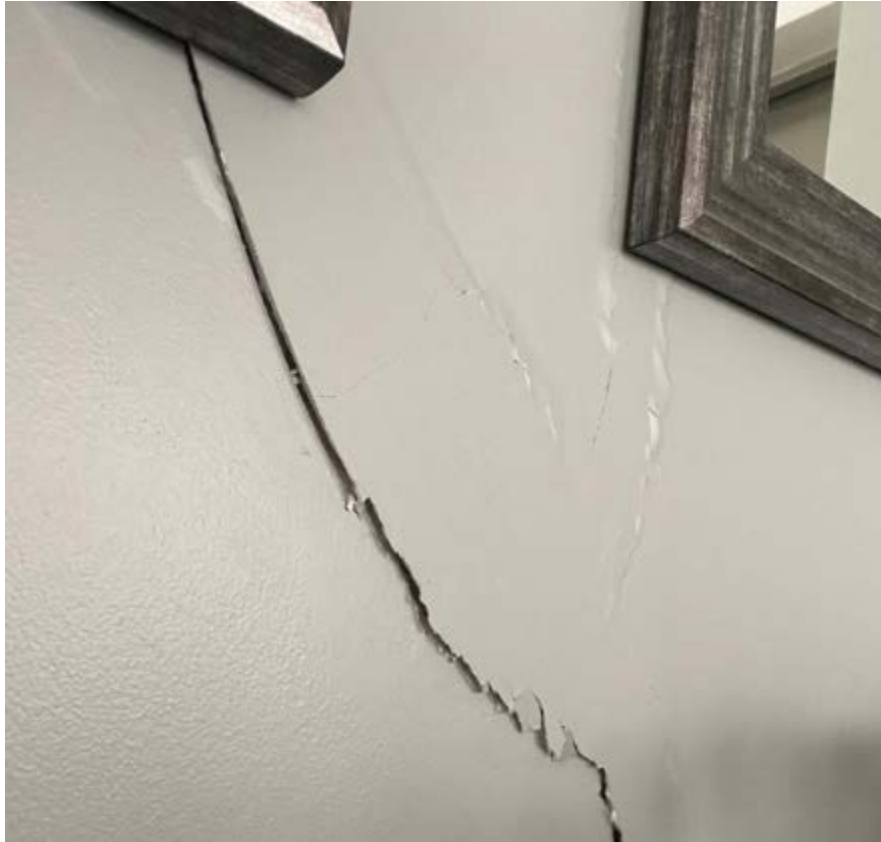
**Figure 8.6. Cracking on drywall partition in an apartment building, Mexico City (CNN en Español, 2020).**
