**Crucecitas, Mexico Mw 7.4  
 Earthquake**

June 23, 2020

**PRELIMINARY VIRTUAL RECONNAISSANCE REPORT (PVRR)**

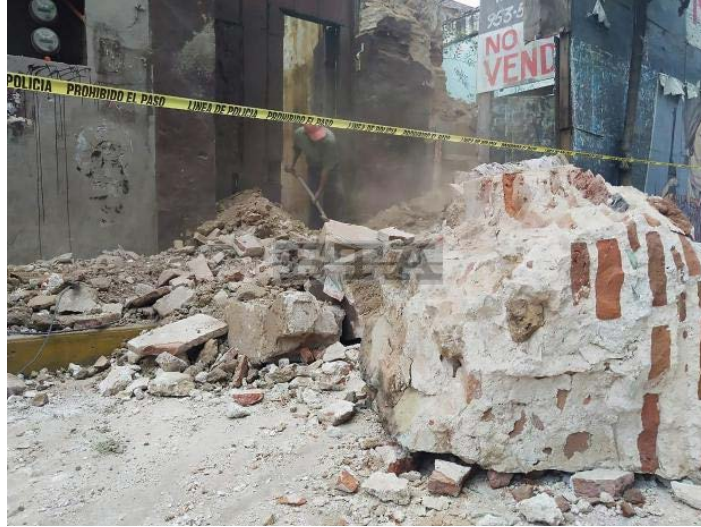
Figure 7.7. Masonry debris after single family building collapse in Oaxaca City (Daily Mail, 2020).

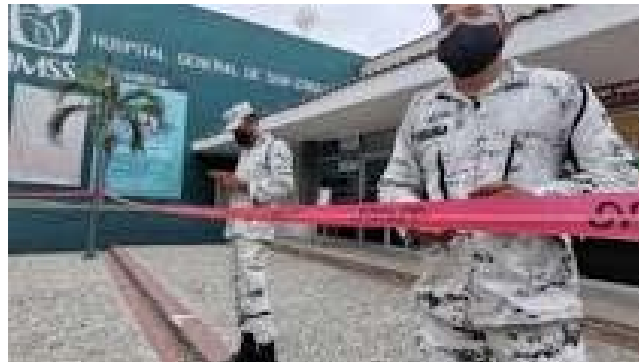
severity of the damage as shown in Figure 7.18. Similarly, the Regional Specialty Hospital of Oaxaca in San Bartolo Coyotepec showed cracking at the exterior walls as shown in Figure 7.19. Additionally, it was reported that the Subzone General Hospital of Huatulco and Family Medical Unit 41, near the epicenter, was evacuated since it requires an in-depth structural evaluation (El Universal, 2020a and El Universal, 2020b). Other medical facilities that experienced damage at the facades were reported by Espinosa (2020b) including the Oaxacan Children's Hospital in San Bartolo Coyotepec and the General Hospital in San Pedro Pochutla experienced minor cracking. Although some hospitals needed to be evacuated in Mexico City, there are no reports of structural damage there.

**Figure 7.20. Closure of the Subzone General Hospital of Huatulco and Family Medical Unit 41 (Hernandez, 2020).**

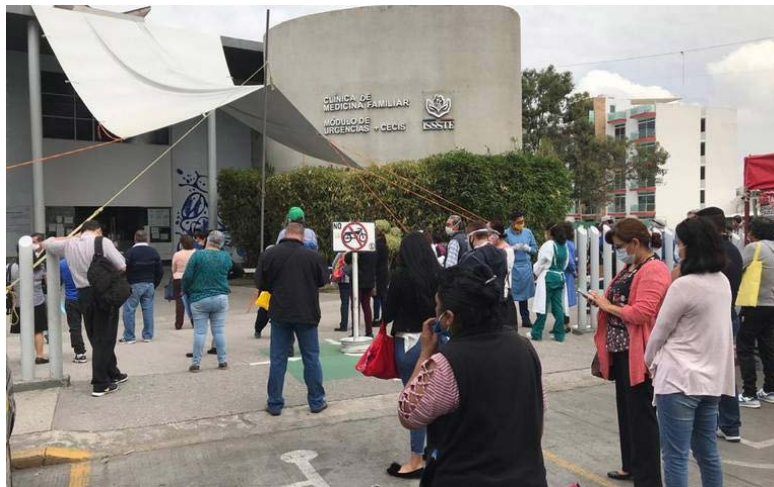
It was reported that the Hospital “Rafael Barba Ocampo” in the City of Cuautla, in the State of Morelos, had some minor damage, such as hairline cracking, but only required closure of some nonstrategic areas (Redacción, 2020). Similarly, it was reported that the healthcare system in the State of Puebla did not suffer any damage and the hospitals continued in operation after being temporarily evacuated for safety reasons (Cuapa, 2020) (Fig. 7.22).

**Figure 7.22. Temporal evacuation of a hospital in the State of Puebla (Ceballos, 2020).**

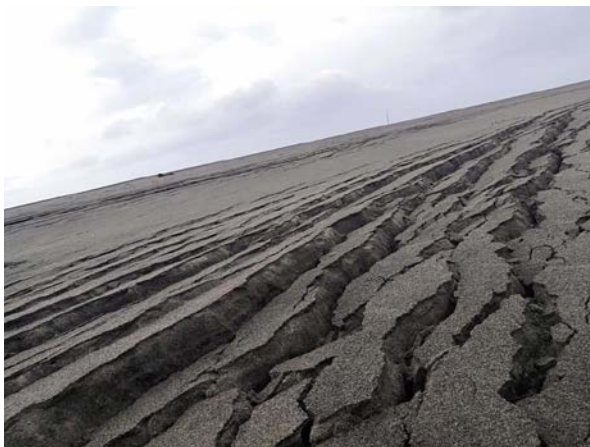
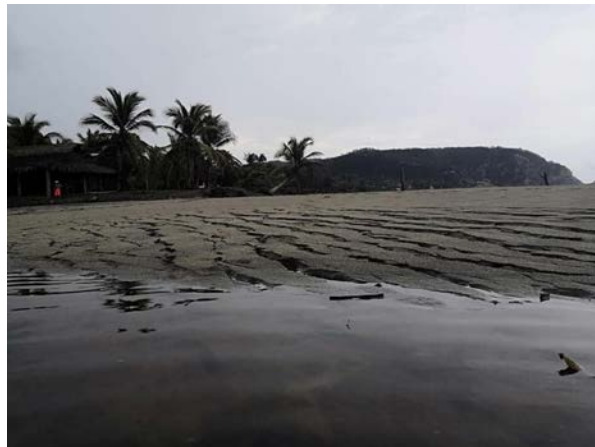
Figure 7.32. Lateral spreading in the beach beach in Huatulco - Oaxaca (Facebook, 2020h and Facebook, 2020i, for left and right, respectively).
